**Benton District Historic Resources  
Survey and Inventory**

*Prepared by*  
**Diana J. Painter, PhD**  
**Sonoma State University**

*for*  
**Anth. 592 – Special Topics in CRM**

**Fall 2004**

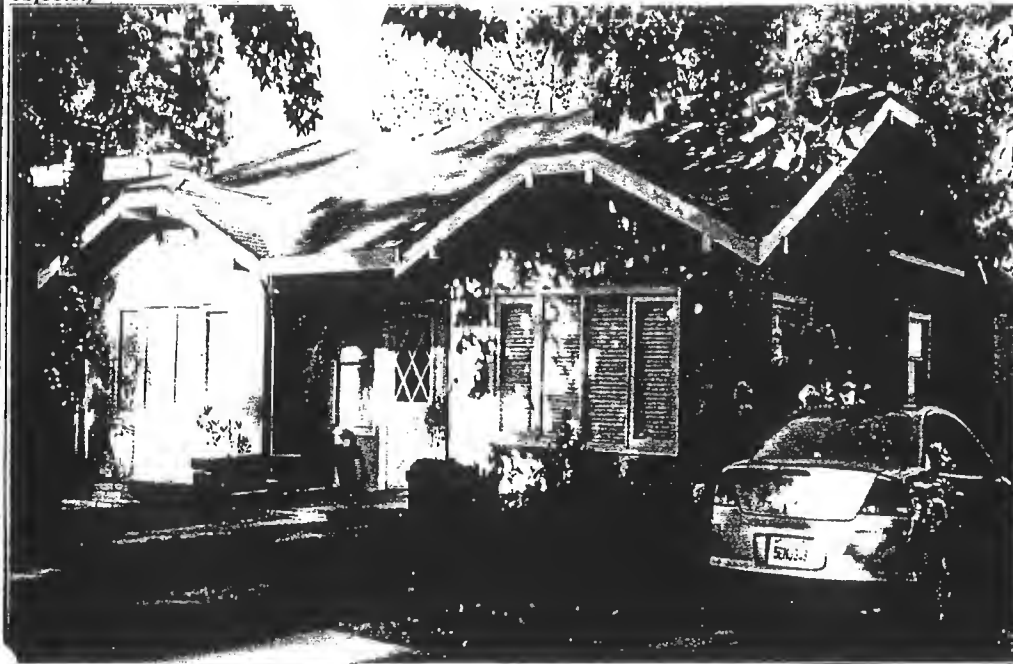
P5a. Photo or Drawing (Photo required for buildings, structures, and objects.)

This is a single story, irregularly-shaped, cross-gabled house with a Jerkinhead low-pitched roof. It is located at 805 King St., toward the front of the lot, with the front façade facing east onto King St. The house is wood frame construction with a stucco finish. One room (which may be a modern addition to the original house), displays horizontal clapboard siding. This room appears to be a square bay with a shed roof. The roof composition shingle and has exposed false beams or eaves brackets. The foundation type is unknown. The house appears to be a bungalow.

P5b. Description of Photo: East elevation, viewed from King Street. October 15, 2004

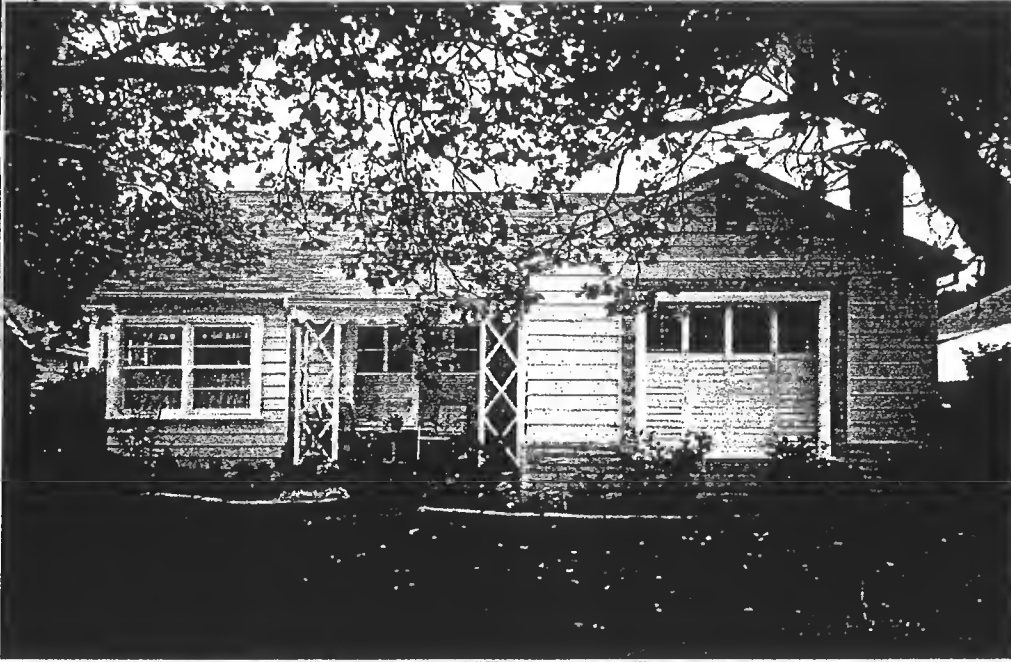
P5a. Photo or Drawing (Photo required for buildings, structures, and objects.)

This is a single story, irregularly shaped house with a moderately pitched cross-gable roof. It is located at 811 King St., toward the front of the lot, with the front façade facing east onto King St. The house is wood frame construction sided with false stone masonry and horizontal clapboard siding. It has a low concrete foundation and a composition shingle roof. The house was built in the Minimal Traditional style.

P5b. Description of Photo: East elevation, viewed from King Street. October 15, 2004

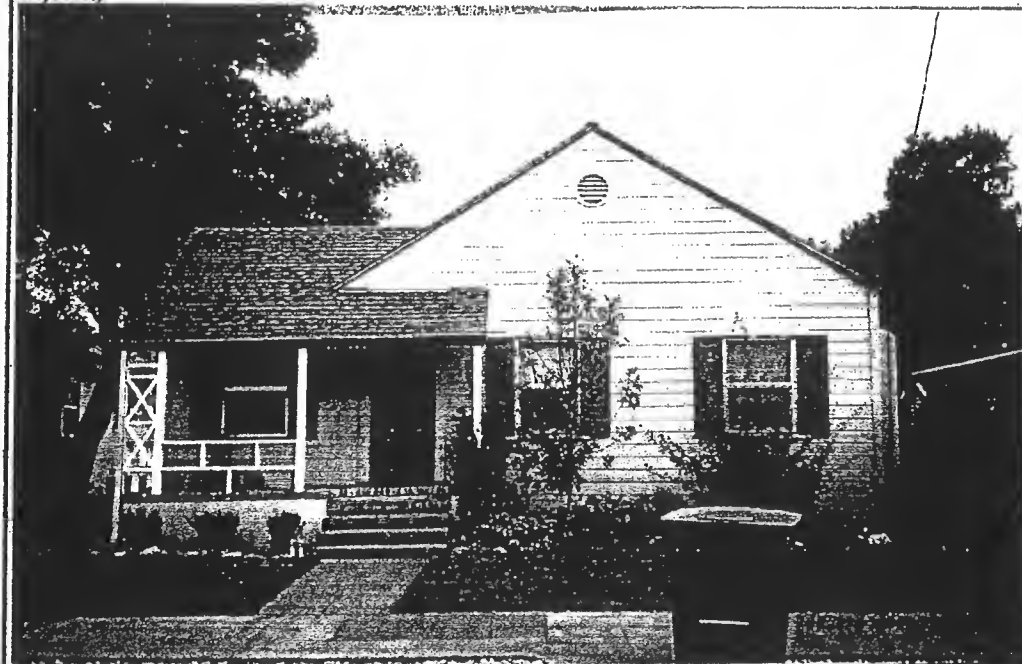
P5a. Photo or Drawing (Photo required for buildings, structures, and objects.)

This is a single story house with an irregular footprint and a moderately pitched cross-gable roof. It is located at 825 Kings St., toward the front of the lot, with the front façade facing east onto King St. It is wood frame construction with horizontal tongue-and-groove siding. The porch has a concrete foundation: the foundation for the rest of the house is not visible. The roof is composition shingle.

This 1925 house has replacement windows. All windows have simple wood surrounds or decorative shutters. The front façade has three one-over-one double-hung windows. On the south facing side there is one large rectangular window and one one-over-one double-hung window. On the north facing side there are three one-over-one double-hung windows (none of which are symmetrical in placement). There are three air vents and three stove pipe outlets projecting from the north-facing roof. A circular vent is located at the top of the main front gable of the house on the front façade.

P5b. Description of Photo: East elevation, viewed from King Street. October 15, 2004.

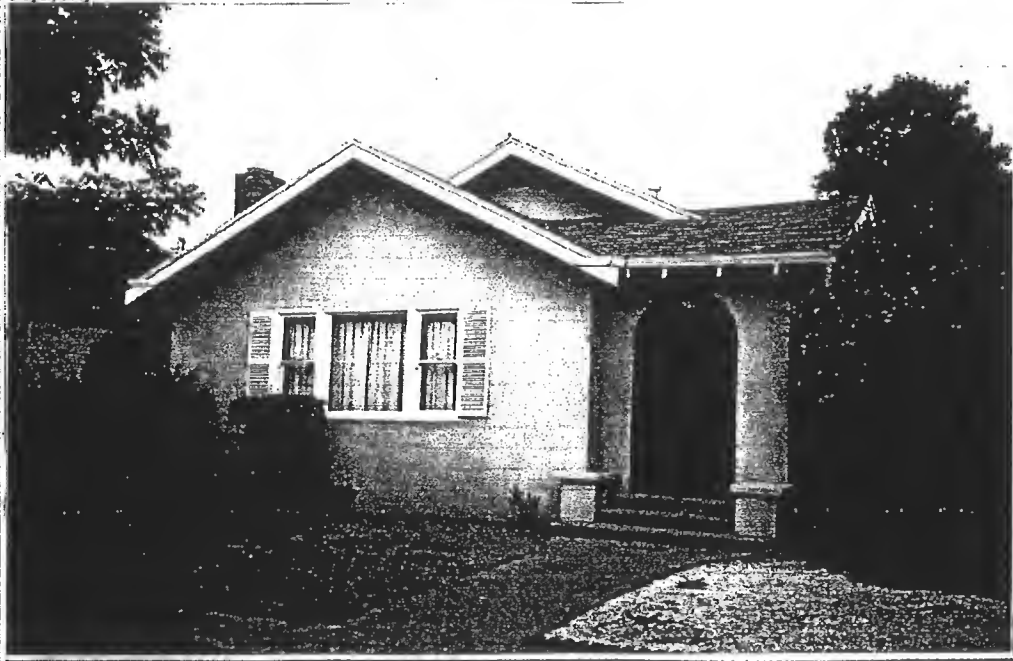
**P5a. Photo or Drawing** (Photo required for buildings, structures, and objects.)

This is a single story house with a rectangular footprint and a moderately-pitched gable roof. The house has multiple gable planes. It is located at 827 King St., toward the front of the lot, with the front façade facing east onto King St. It is wood frame construction with a stucco finish. The foundation is not visible. The roof is composition shingle. The modest vernacular house or bungalow was built in 1929.

**P5b. Description of Photo:** East elevation, viewed from King Street. October 15, 2004

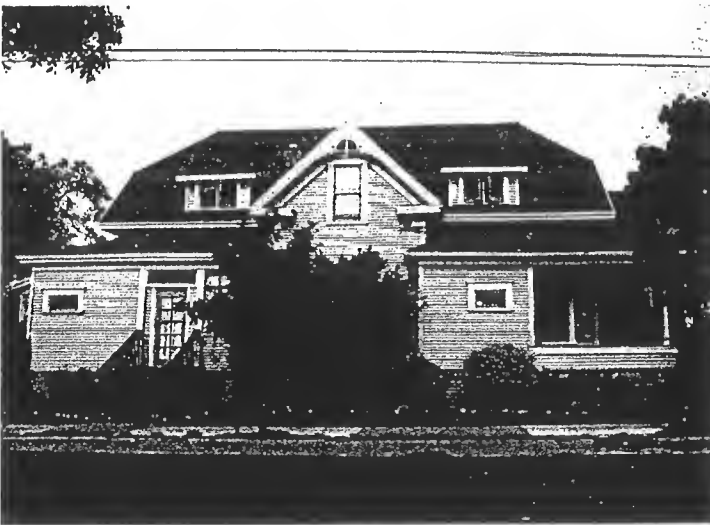
4) View from Benton St. looking N.

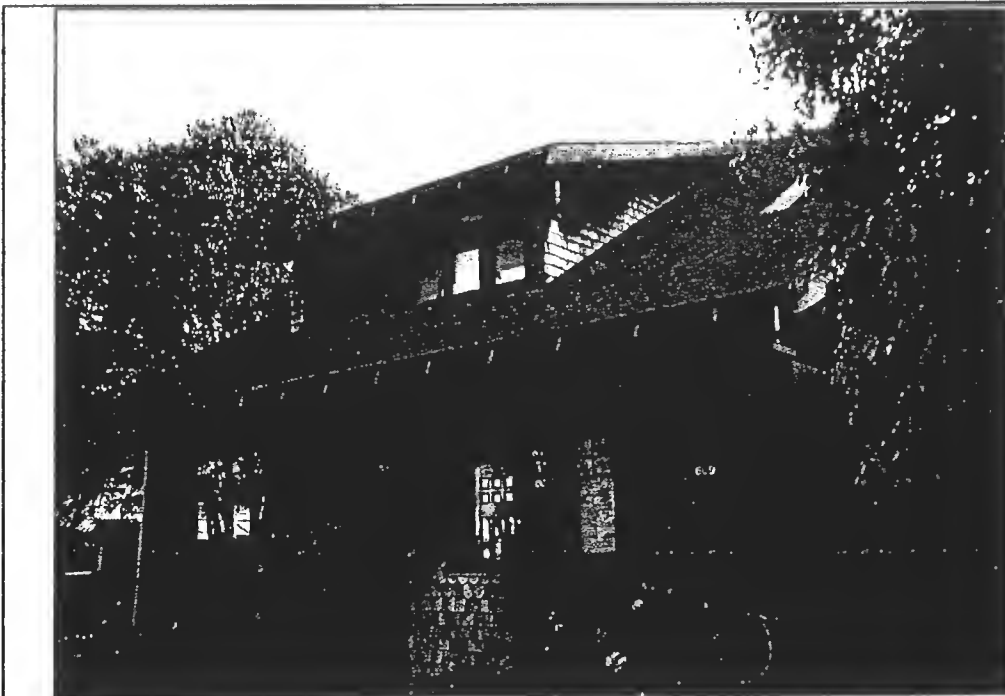
\*P3a. Description: The main house at 807 and 809 Orchard is one-and-a-half stories with a nearly square footprint. It features a moderately-pitched side-gable composition shingle roof, whose ridge runs north-south parallel to Orchard Street. It is wood frame construction with a low concrete foundation, and sided with a combination of square and fishscale shingles. The building is in the Craftsman style, but with many flourishes that set it apart from more typical Craftsman Bungalows found in this neighborhood.

P5b. Description of Photo:  
View from Orchard looking  
WSW.

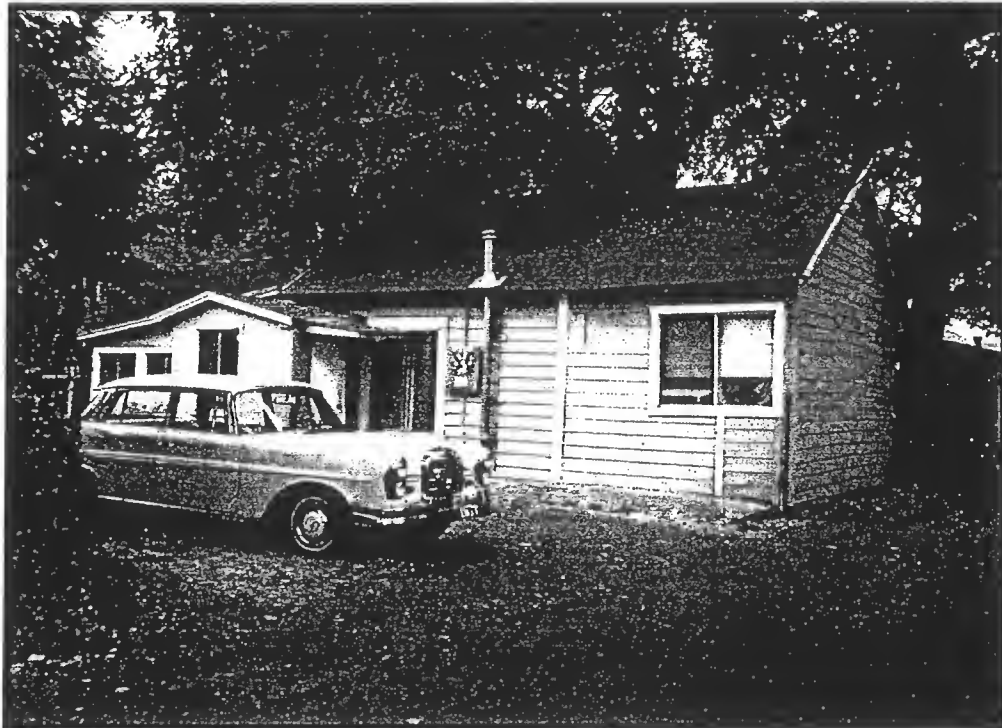
814 ½ Orchard is a one-story residence on the back of the lot on which #814 is located. The main entrance is enclosed within a gable-roofed enclosed porch with shed-roof extension, and faces the alley. The house has a square plan and poured concrete foundation. It has horizontal wood siding and exposed rafters. It has a side-gable roof of moderate pitch, and is finished in composition shingles. The windows are two-light sliding sash, vertically divided, with plain trim. The northernmost portion of the building appears to be a later addition. In addition, there appears to be a smaller shed-roof addition to the south side of the house, and at least two windows have been enclosed. At least three additions appear to have been made to the house.

814 ½ Orchard Street; taken from alley between Orchard and Beaver Streets, view to northwest.

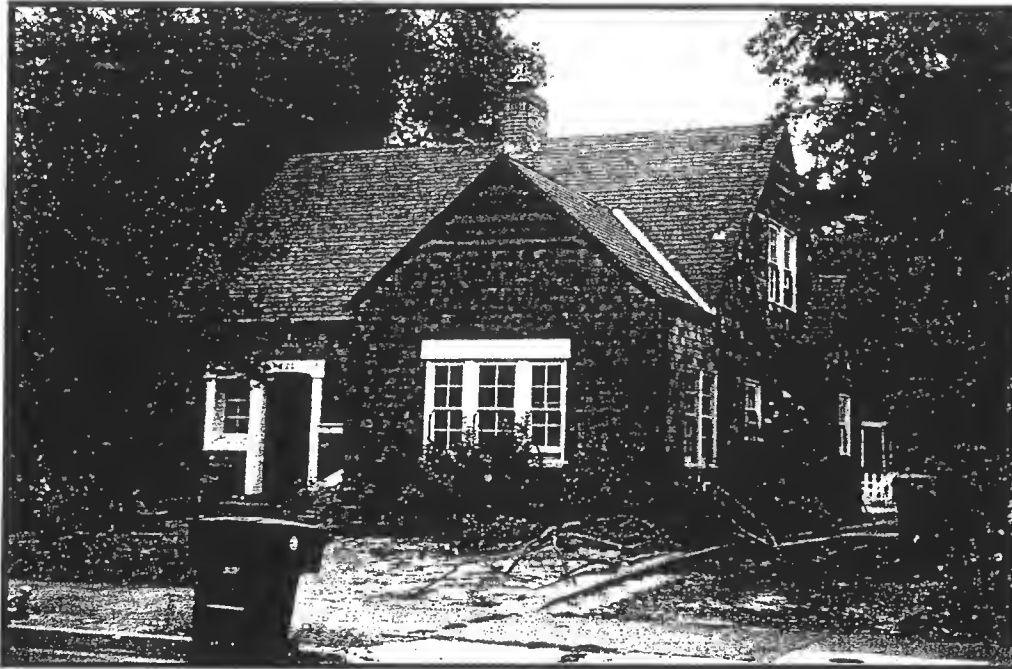
This 1936 cottage with Tudor Revival influences at 820 Orchard Street is two stories with an irregular, but roughly L-shaped, footprint. It is oriented toward the west. It features a steeply pitched, cross-gable roof, with a centrally-placed interior chimney. The building is of wood construction with a concrete foundation, and is finished with coursed natural redwood shingles. The windows are mostly double-hung with four-over-four lights. They are paired on the side facades and placed in a set of three on the front facade of the house, the latter with heavy mullions. A narrow sidelight with three rows of two lights is adjacent to the left side of the door. The tripartite window on the front façade is topped by a wide, plain lintel. The door has a similar treatment, but with a slight arch to its underside, while door surrounds feature plain trim. Broad strips of what appears to be a ferrous metal decorate the gables on all faces.

P5b. Description of Photo:  
814 Orchard Street residence, view  
to northeast

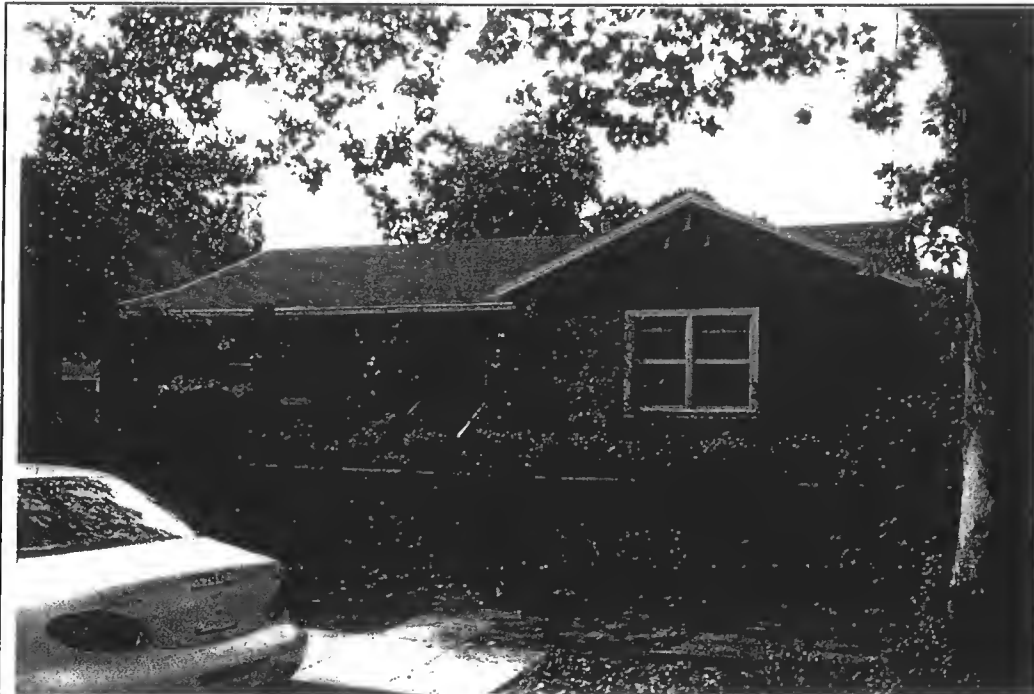
\*P3a. Description: The main house at 823 Orchard is a single-story rectangular building with a low-pitched cross-gable roof whose main ridge runs north-south, parallel to Orchard Street. The roof is composition shingle, and the building is faced with tongue-and-groove siding. It has a low foundation with a brick face. It is ca. 1940 Minimal Traditional home.

P5b. Description of Photo:  
View from Orchard St looking W

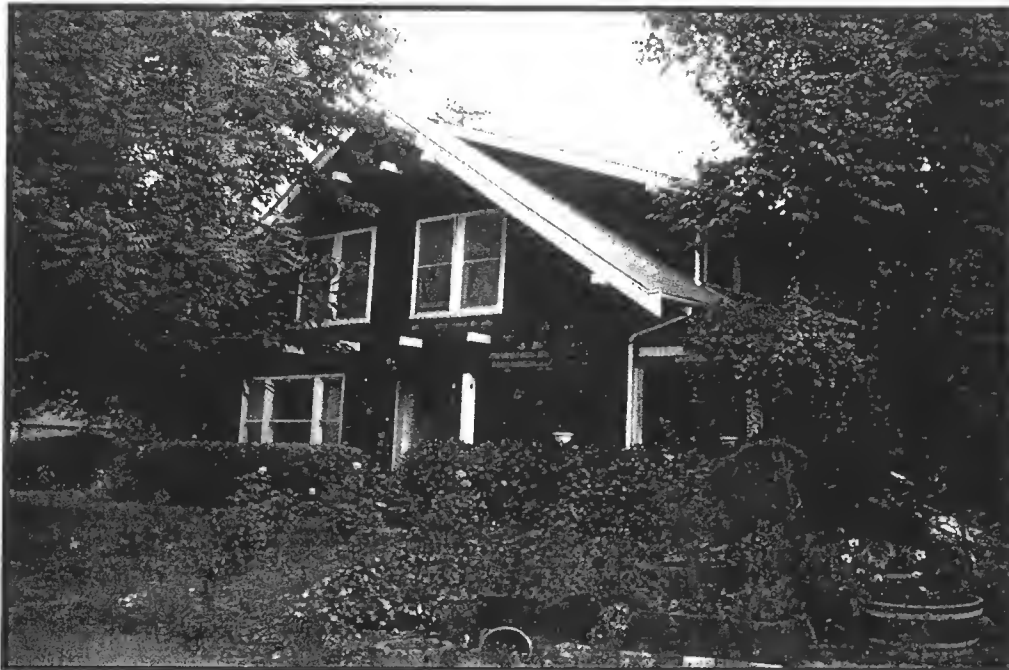
This 1922 Craftsman residence is two stories with a rectangular footprint and a steeply pitched front gable roof. It is oriented west, towards Orchard Street. A shed-roof dormer extending nearly the length of the south façade creates a second story on this side. The house is wood frame construction with a concrete foundation and coursed natural shingle siding. It features a recessed porch on the right side of the front facade, supported with plain square posts.

P5b. Description of Photo:  
824 Orchard Street residence, view  
to northeast.

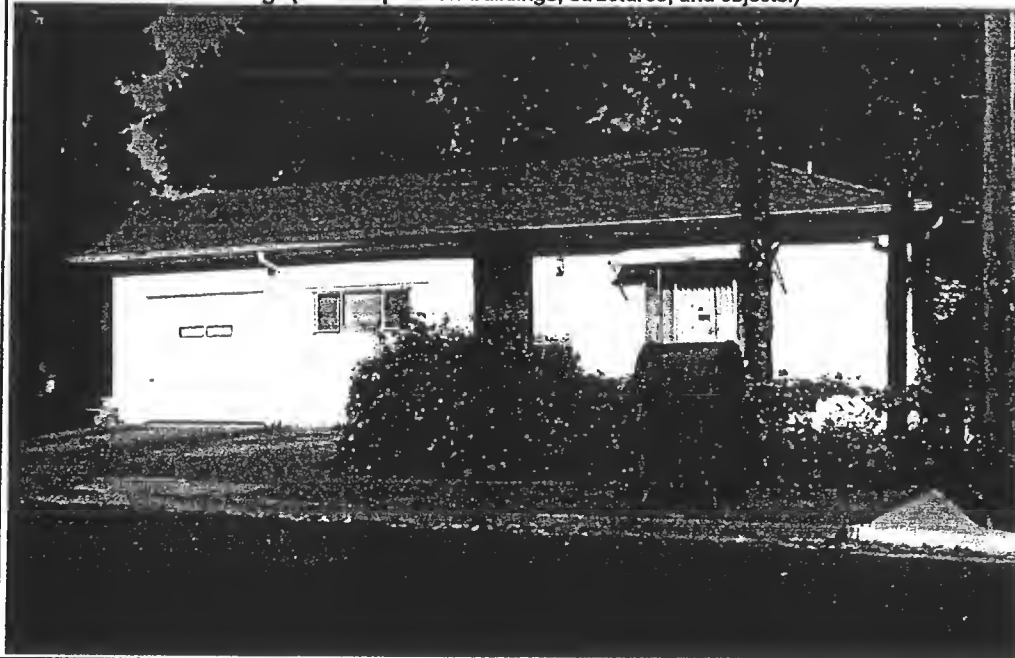
P5a. Photo or Drawing (Photo required for buildings, structures, and objects.)

\*P3a. Description: (Describe resource and its major elements. Include design, materials, condition, alterations, size, setting, and boundaries)  
This is one-story, duplex with a rectangular footprint and a hip roof of composition shingle. It is wood frame construction with a stucco finish. At the center of the front façade of this Ranch- style residence, ca.1955, is a garage with two, small rectangular lights. A second garage next to this has been converted. A two-step, cement stoop leads to two plain wood front doors covered by two-panel screen doors, one on either side of the garage. The door to the south of the garage is flanked by two, two-light casement windows, the one closest to the corner being large and square in shape, with an aluminum awning. The other window is rectangular and horizontally-oriented. At the back of the building on the east and south facades are two rectangular, horizontally-oriented two-light casement windows. There is also a one-light casement window on the south side. All windows are aluminum-framed and slightly recessed.

P5b. Description of Photo: (View, date, accession #)  
West elevation, viewed from Orchard Street, 14 September 2004.

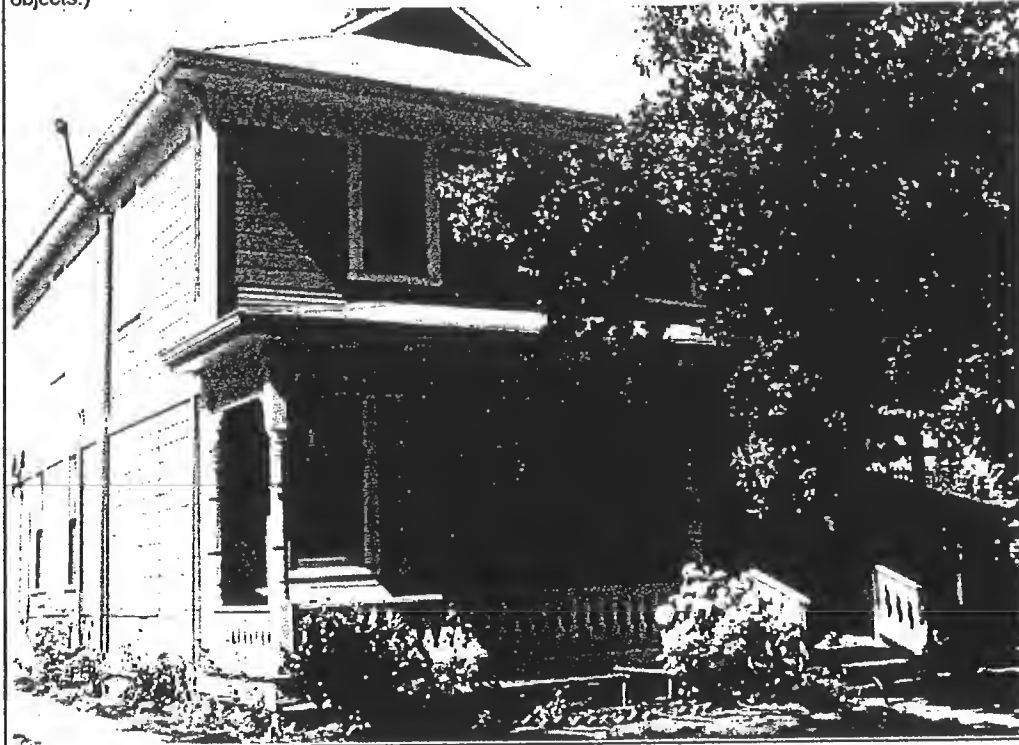
P5a. Photo or Drawing (Photo required for buildings, structures, and objects.)

\*P3a. **Description:** (Describe resource and its major elements. Include design, materials, condition, alterations, size, setting, and boundaries)  
This is a two-story Folk Victorian built in 1895. It is a wood frame house on a rectangular foot print with a hip-on-gable roof, boxed eaves. The roof has decorative scalloped frieze band at the second story and plain wood belt course at the first level. The front façade faces east and has a full-width, three bay porch with a hipped roof. This features spindlework under the eaves, five turned porch supports, a balustrade made up of turned balusters, and three steps leading down to the walkway. Another small transom light above. To the left of the door is a bay window with three one-over-one-light windows. There are two windows on the second story, and two one-over-one sash windows on both the first and second stories on the south, side facade. On the north facade there are three one-over-one-light windows on the second floor with two small fixed windows on the first floor. The house has an interior fireplace and rests on a concrete foundation with a stone foundation under the porch. The siding is shiplap. There is driveway on the south side of the house leading to a detached garage in the back. The condition of the house is good.

P5b. **Description of Photo:** (View, date, accession #)  
Elevation from the south, viewed from Orchard  
October 15, 2004

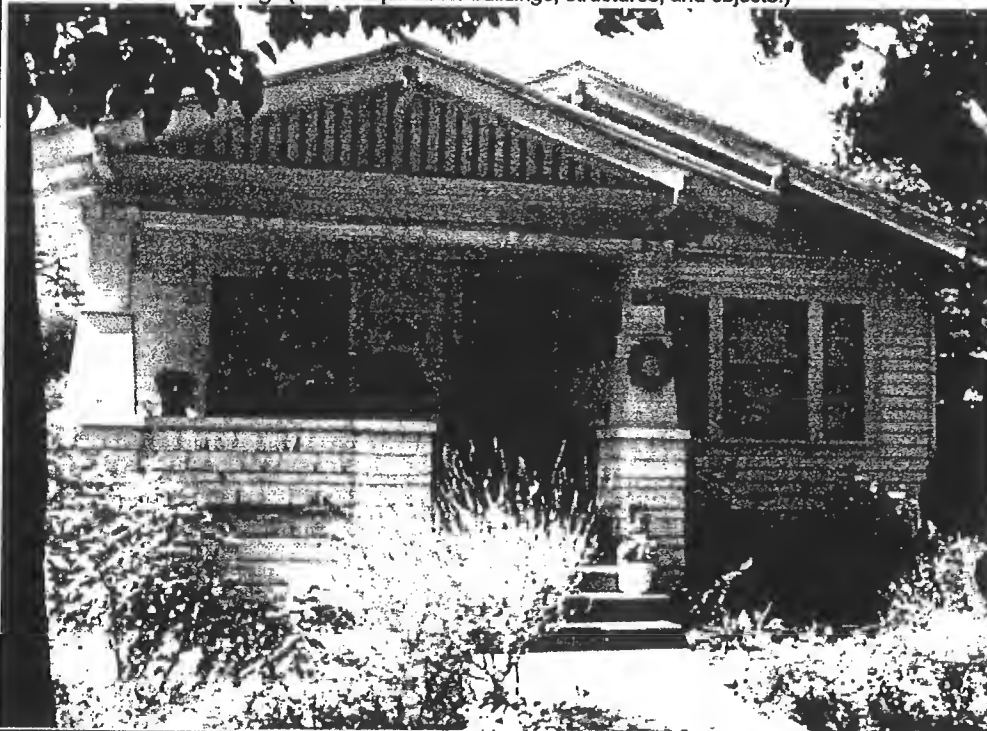
**P5a. Photo or Drawing** (Photo required for buildings, structures, and objects.)

**P5b. Description of Photo:** (View, date, accession #) East facade

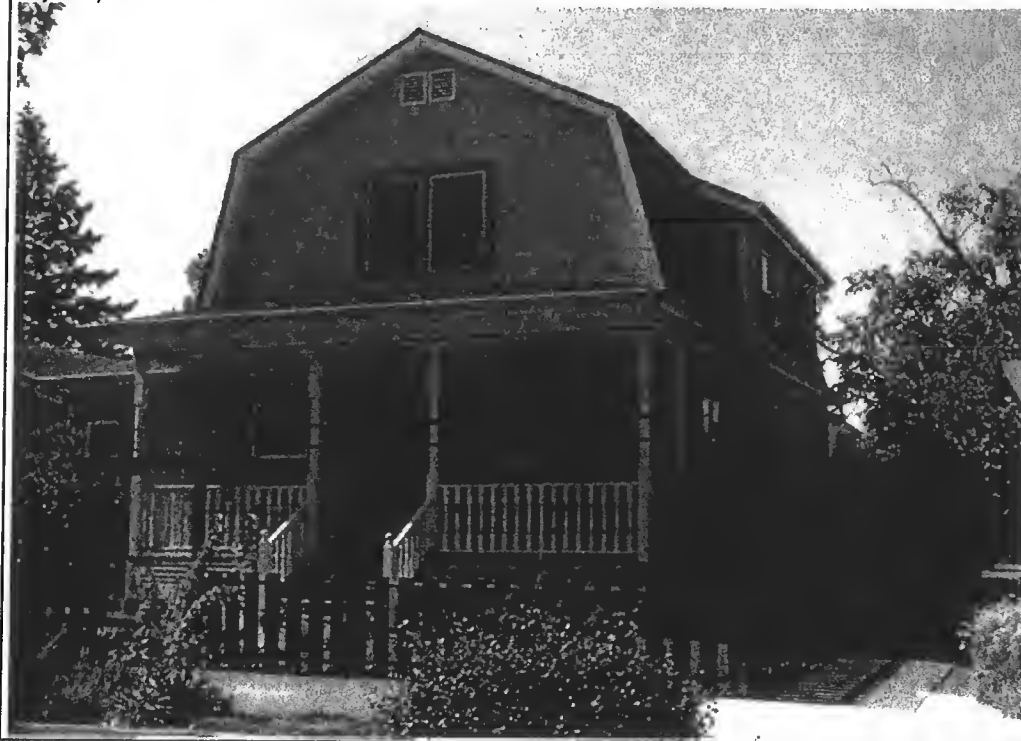
**P5a. Photo or Drawing** (Photo required for buildings, structures, and objects.)

East elevation,  
viewed from Orchard,  
October 15, 2004

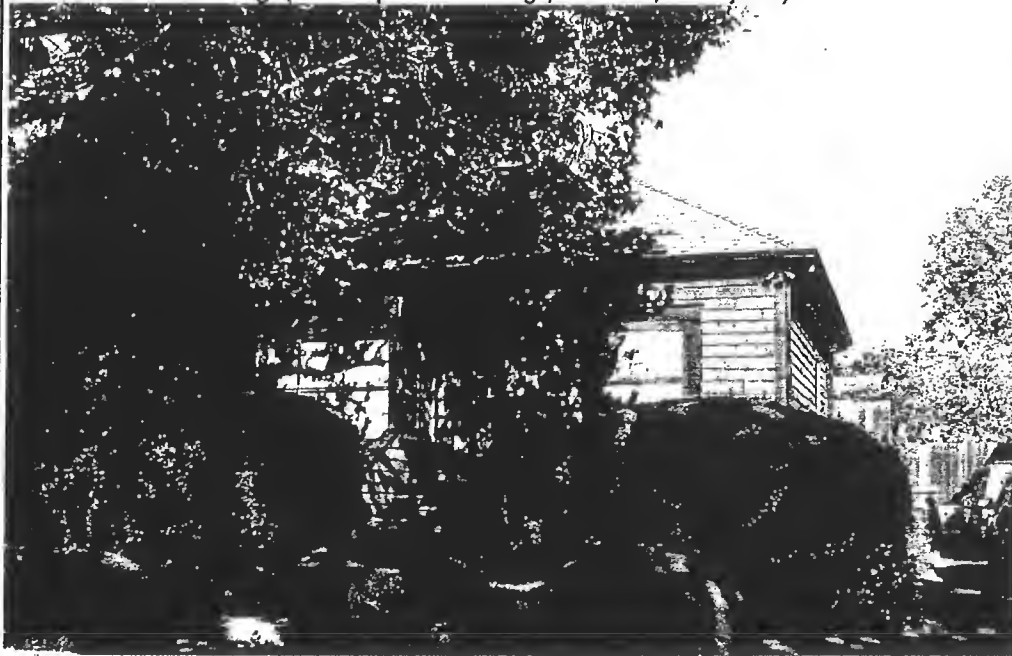
**P5a. Photo or Drawing** (Photo required for buildings, structures, and objects.)

**P5b. Description of Photo:** (View, date, accession #) 10/10/04

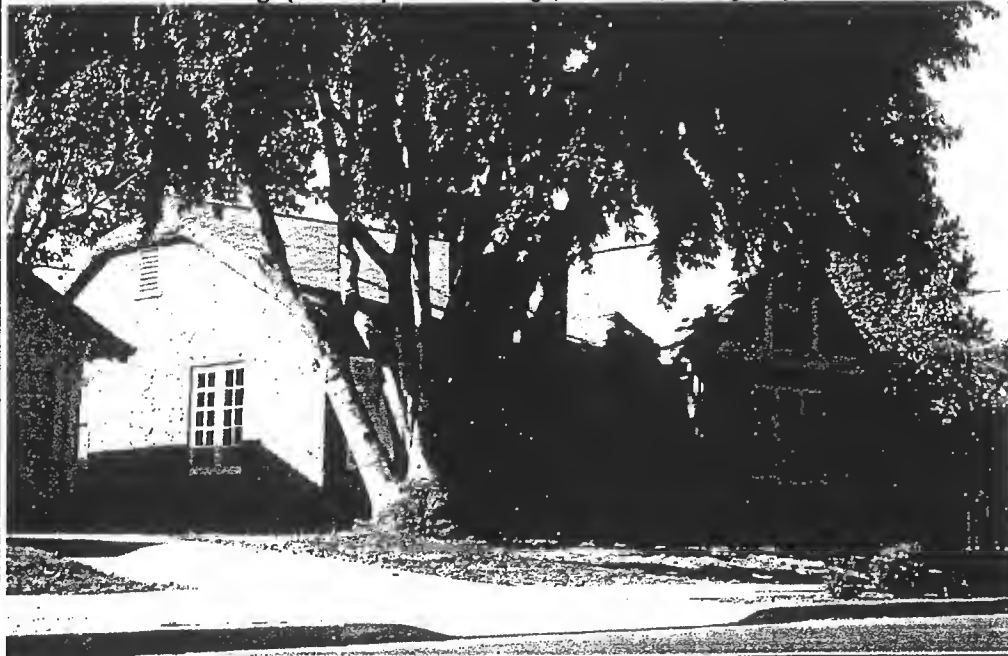
**P5a. Photo or Drawing** (Photo required for buildings, structures, and objects.)

View toward the southwest taken 20 September 2004

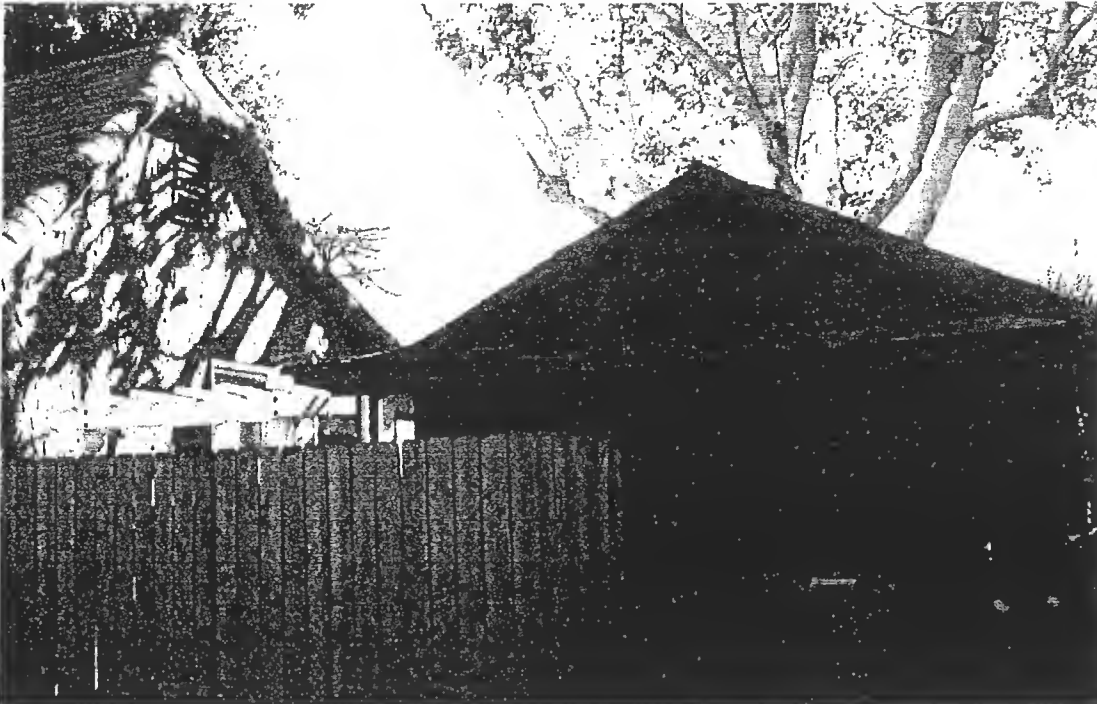
An original outbuilding of wood board and batten in the rear of home.

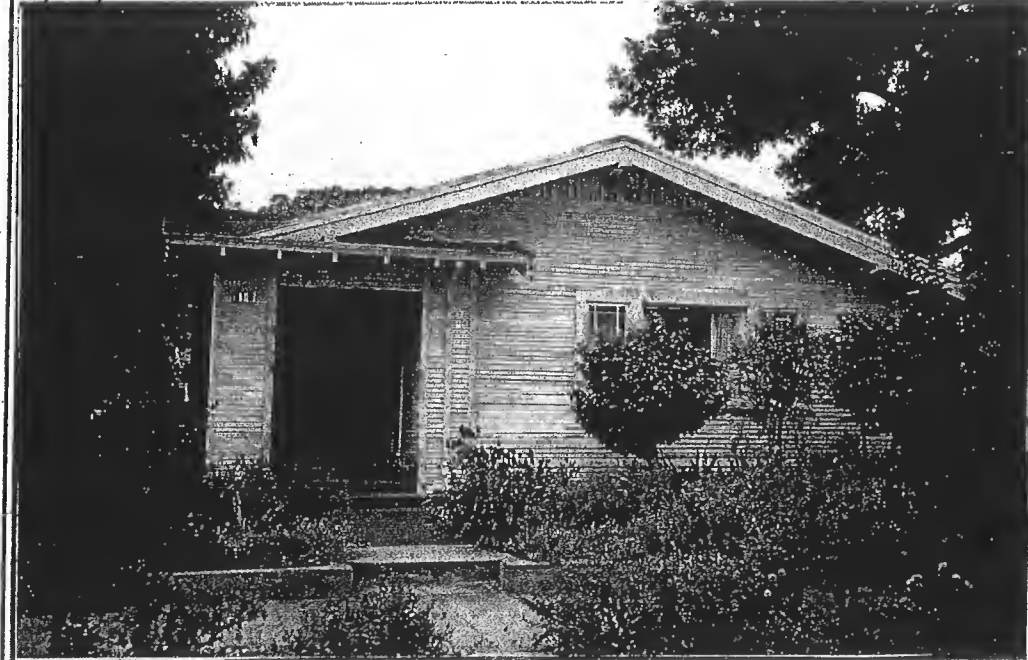
P5a. Photo or Drawing (Photo required for buildings, structures, and objects.)

This is a single story house with a rectangular footprint and a low-to-moderately pitched front-gable roof. It is located at 916 Nason Street, toward the front of the lot, with the front façade facing north. It is wood frame construction with horizontal wood clapboard siding. The house has a low concrete foundation, approximately four inches of which is visible. It has a built up roof of tar and gravel. The house is a bungalow built in 1930.

P5b. Description of Photo: North elevation, viewed from Nason St., October 15, 2004

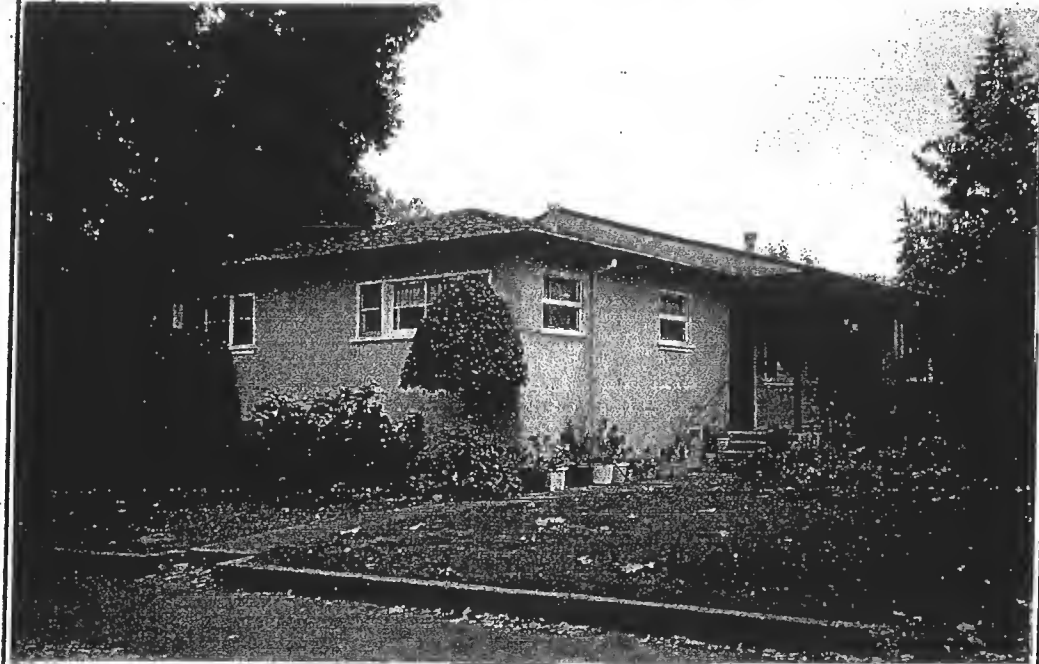
P5a. Photo or Drawing (Photo required for buildings, structures, and objects.)

This is a single story house with a rectangular footprint and a low-pitched hipped roof. The hipped roof is over the front of the house. It is intersected by a gable at the porch line on the west facade. It is located at 920 Nason St., toward the front of the lot, with the front facade facing north onto Nason St. It is wood frame construction with vertical wood siding. The house has a painted exterior finish, but sections of the house have different textured paint finishes than others. The foundation is not visible. The roof is composition shingle. The house was constructed in 1952.

P5b. Description of Photo: North elevation, viewed from Nason St., October 15, 2004
